Toward a Walkable El Camino Real: An Analysis of Opportunities and Barriers

Santa Clara University

Sara Kelly, Ryan Kincheloe, Travis Osland, and Bezan Pithawalla

Senior Capstone, March 2018

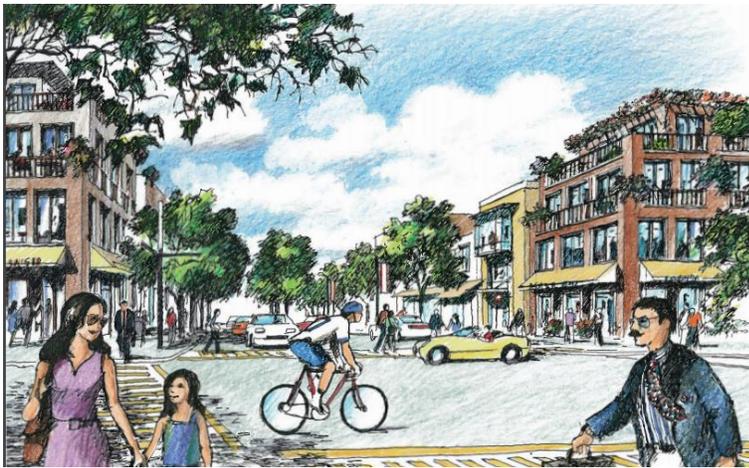
Figure 2: Compact Development Example from Menlo Park's El Camino Specific Plan (City of Menlo Park, 2012)

The research on how urban design and planning can be used to reduce transportation emissions commonly measures vehicle miles traveled (VMT). VMT refers to the amount of miles that vehicles are traveling, and therefore when individuals carpool, or take public transport, they are reducing overall VMT by splitting their miles with others. Studies show that more compact development can decrease VMT by concentrating people around downtown areas, increasing household density, increasing nearby job accessibility, and improving street connectivity (Stevens, 2017). While the exact extent to which compact development can decrease VMT is debated, one meta-analysis estimated that doubling housing density can reduce VMT by 5 to 12 percent (National Resource Council, 2010). An example of a more compact development can be seen in Figure 2.

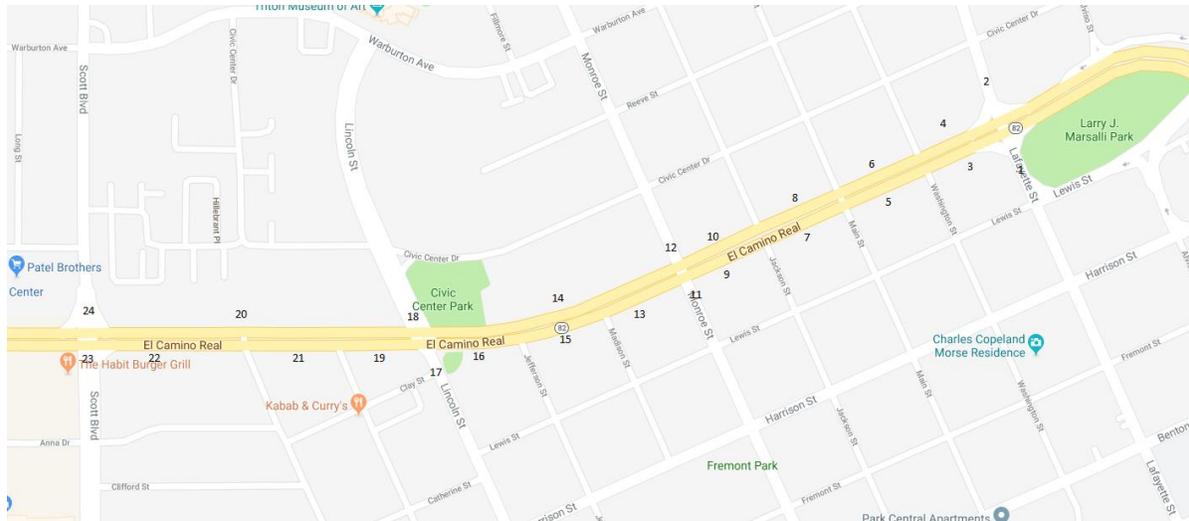
Figure 4: Identified blocks in study area for PEDS walking audit analysis

To collect the necessary data, such as street lights, abandoned buildings, speed limit, etc. for our GIS analysis we conducted a Pedestrian Environmental Data Scan (PEDS) walking audit. The PEDS walking audit, was developed to measure the environmental features that affect walking (Clifton et. al, 2007). Specifically for identifying environmental features of an area that influence walking and therefore has a high utility for our study’s purposes (Clifton et. al, 2007). Before conducting the audit, we identified 24 blocks in our study area to be audited by splitting up El Camino Real and four of the major side streets (Lafayette, Monroe, Lincoln, Scott) into its natural street blocks (Figure 4).

There are many sidewalk obstructions along El Camino Real. Every block studied but one (Block 1, Figure 4), contained either signs, poles or several medium/high volume driveways that blocked part of the sidewalk.

Only one drinking fountain was located along the study region, on block 18 (Figure 4). It was located within Civic Center Park, and not very visible to pedestrians along the corridor.

Most of the sidewalks along the corridor were actually in fairly good condition, and we did not rate a single block as having poor sidewalk maintenance (defined as many bumps/cracks/holes). Fifteen out of the 24 blocks were rated as fair (defined as: some bumps/cracks/holes) and the remaining 9 as good (defined as: very few bumps, cracks or holes). The distribution of the fair-rated sidewalks are fairly evenly distributed throughout the study area, the only exception being a stretch of five straight poor ratings from blocks 10-14, which includes two blocks on Monroe boulevard (Figure 4).

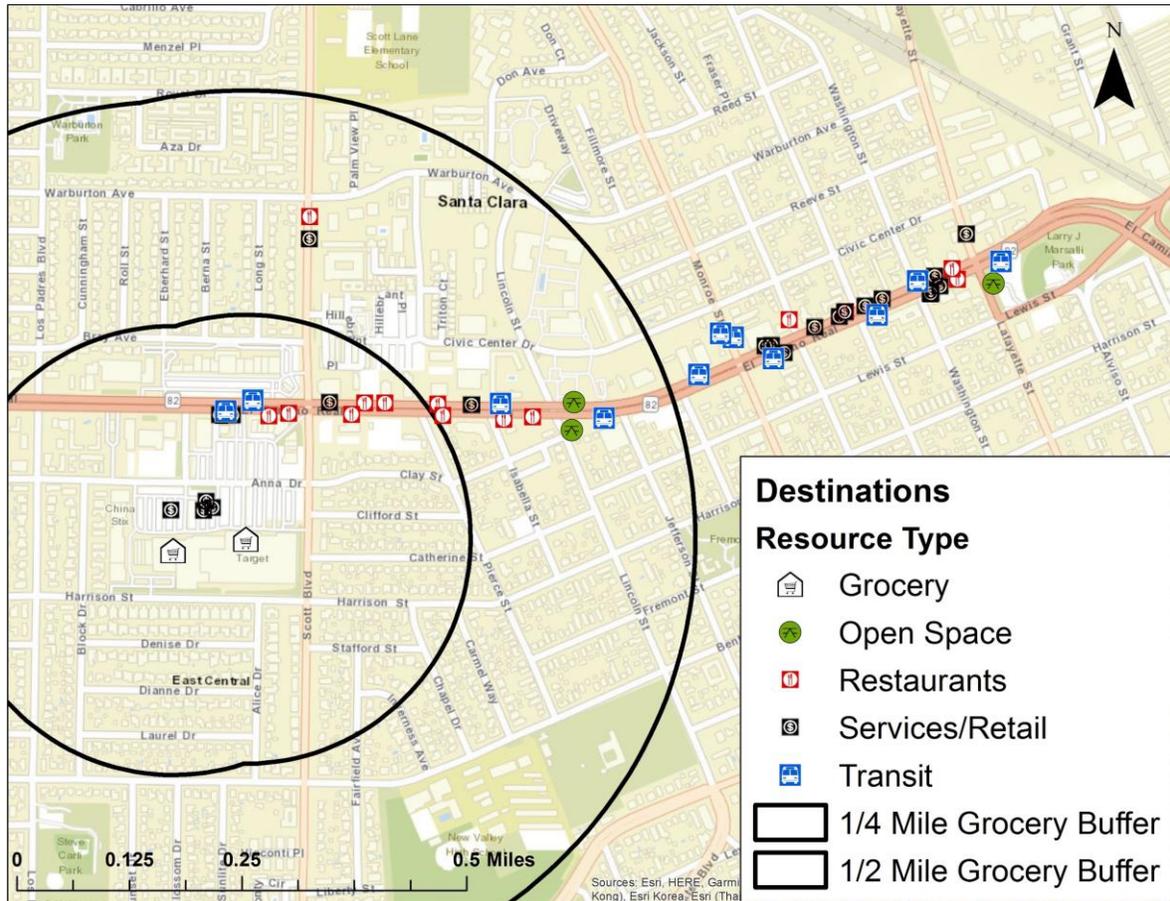
Figure 6: ArcGIS spatial analysis of El Camino Real destinations and grocery availability

Visually representing the results of the walk audit allowed us to analyze our study area from multiple perspectives (Figure 6). This helped us gain a more thorough understanding of the current walkability on El Camino Real.

Our walk audit results show that El Camino Real has 47 walkable destinations and 10 transit stops along the corridor (Figure 6). Twenty-eight of the destinations were classified as retail/service, 14 as restaurants, two as grocery stores, and three as open spaces. The vast majority of these destinations, except the three located on Scott Boulevard and Santa Clara Town Centre destinations are located directly on the El Camino.

Along the corridor, we identified two grocery stores, Sprouts and Target (located in the Southwestern portion of Figure 6). Neither Sprouts nor Target are full-service grocery stores. The ¼ and ½ mile buffers surrounding these grocery stores serve to show the lack of very close grocery options for the vast majority of the study section. However, it would take a considerable increase in residential density to justify a grocery store within a ½ mile of all the residents in the area. If more housing development continues down the road, it would be more conducive to a full-service grocery store.

Retail/services was the largest category of destinations observed in the study area. This destination type was distributed mainly on the eastern and western extremes of the map, with only two falling in between Monroe and Scott Boulevard (Figure 6). The types of retail/service appear to be fairly diverse and included options such as banks, a pharmacy, a dentistry, a shoe stores, and flower shop--the only notable exception to this being the three hair and nail salons that fall within the study region.

The 14 restaurants in the study region are mainly located on the western portion of the corridor (Figure 6). Eleven of the restaurants are located west of Lincoln St, leaving only three to the rest of the study area. This is also notable given the lack of grocery stores also observed in the eastern portion of the study region, forcing residents in this area to take transit or personal vehicles to get groceries. Moreover, eight of the restaurants were fast food chains, leaving fewer options for fresh foods for local residents all along the study area.

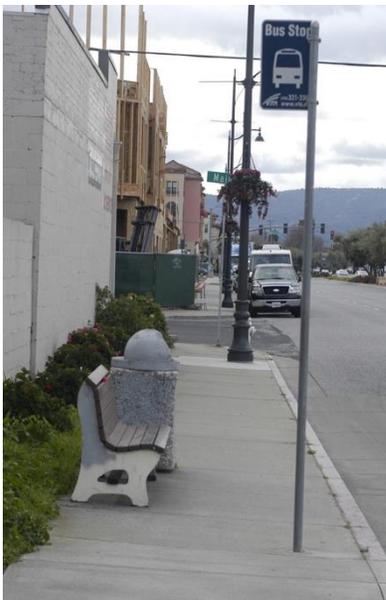
Figure 7: Typical transit stop

The transit stops along El Camino Real, all bus stops, are mostly uniform and evenly dispersed. Five are located east of Monroe street and five are located west of Monroe. An example of a typical bus stop along the route can be seen in Figure 7. The only transit stop observed to have a shelter was on the southeastern corner of El Camino Real and Scott Blvd.

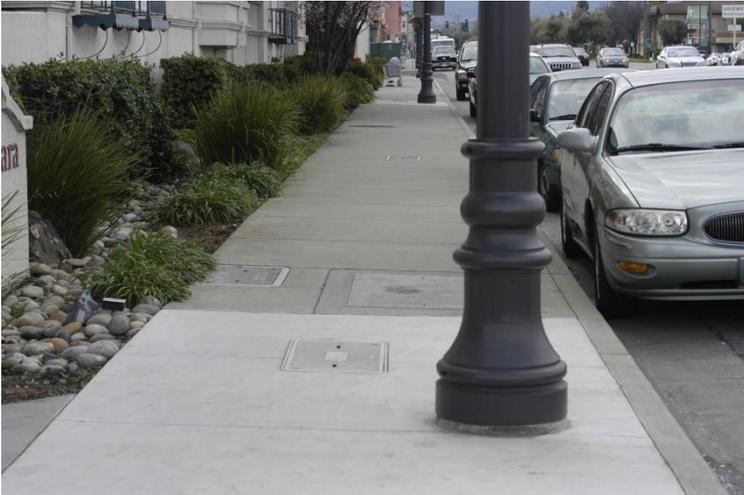
Figure 8: Example of pole obstruction and narrowed sidewalk

Signs/poles were the main obstruction observed, 22 of the 24 blocks studied contained this sort of obstruction. The only blocks not containing these signs or poles were the side streets of Lafayette and Lincoln. These shortened the effective width of the sidewalk by about 1-2 feet (Figure 8). Other examples of obstructions included benches, overgrown greenery, and garbage cans, but only existed on 25 percent of the blocks and did not appear to be very consistent obstructions in the study area.

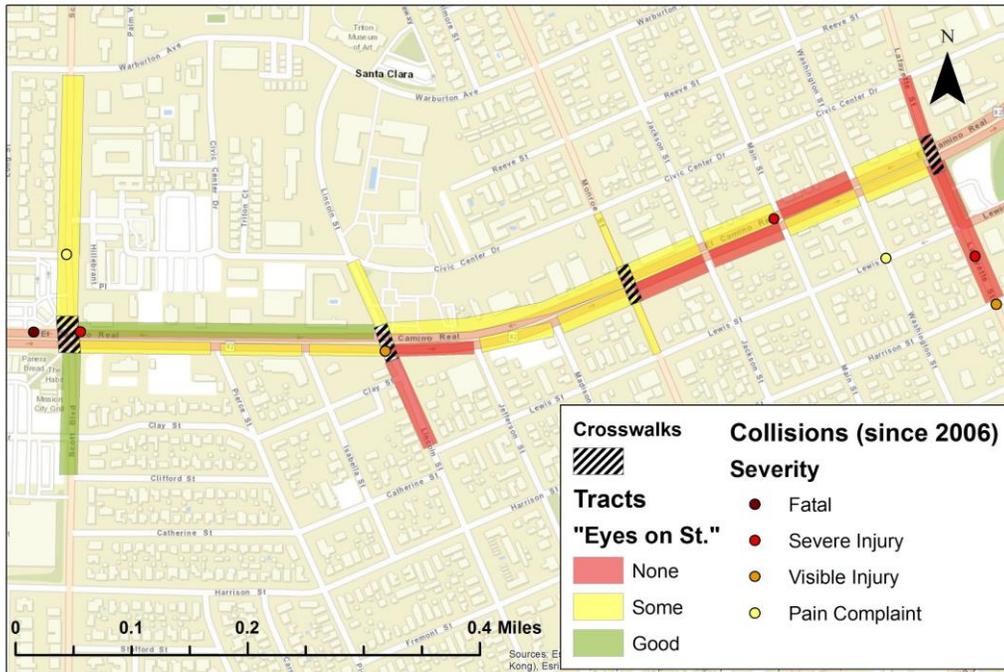
Figure 9: El Camino Real safety concerns and pedestrian collisions

Our survey focused on participants' opinions of the current state of the El Camino and potential future developments asking questions about demographics, how often they walk along El Camino Real, their perceived strengths and weaknesses of El Camino Real and their opinions on proposed changes to the road. Again, we surveyed 9 users of El Camino Real. Three of our survey respondents said that they had trouble with reaching the attractions along El Camino Real. They said that they had to walk about half a mile before reaching any restaurants and stores. However, six respondents said that they had no problem with walking along El Camino Real, and thought that the sidewalks and crosswalks were wide enough to walk through. It is unknown whether the respondents we surveyed were residents living near El Camino Real or if they were just frequent visitors from different communities. One of the biggest strengths that they stated was that there were many restaurants and stores to visit along El Camino Real. seven respondents didn't have a problem with the amount of shops/stores along the street. Figure 6 shows that there are multiple restaurants within our targeted one mile radius from Lafayette Street to Scott Boulevard.

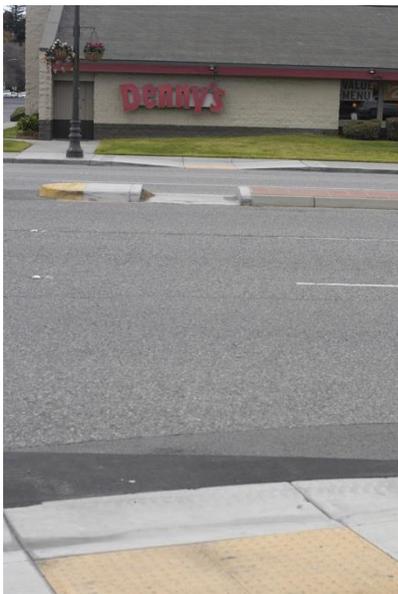
Figure 10: Example of 8 lane crossing with no crosswalk

One of the major safety related observations along El Camino concerned the amount of protected crosswalks for pedestrians. The only crosswalks available for pedestrians to cross the El Camino were at the major side streets of Lafayette, Monroe, Lincoln and Scott (Figure 10). One area observed even had curb cuts through the median to suggest that it was a route for pedestrians, but contained no other crossing aids or traffic controls for pedestrians to make it across the six lanes of high speed traffic.

The lack of protected crosswalks for the El Camino were also observed to be a major area of concern for the safety of the corridor. There were only four crosswalks across the El Camino in the study region, forcing pedestrians to potentially travel much further in order to get to a crosswalk in order to traverse the busy road. This ends up encouraging people to jaywalk as it is a much faster alternative. Jaywalking, although a social construct pushed by the auto industry, is still an inherently dangerous activity, and the lack of crosswalks is almost certainly contributing to this behavior (Stromberg, 2015). We witnessed numerous jaywalkers attempting to cross to El Camino Real during our walk audit, despite the general lack of pedestrians along the street. Further, there were no crosswalks for the side street crosswalks lining the El Camino, potentially increasing the likelihood for pedestrian related accidents.

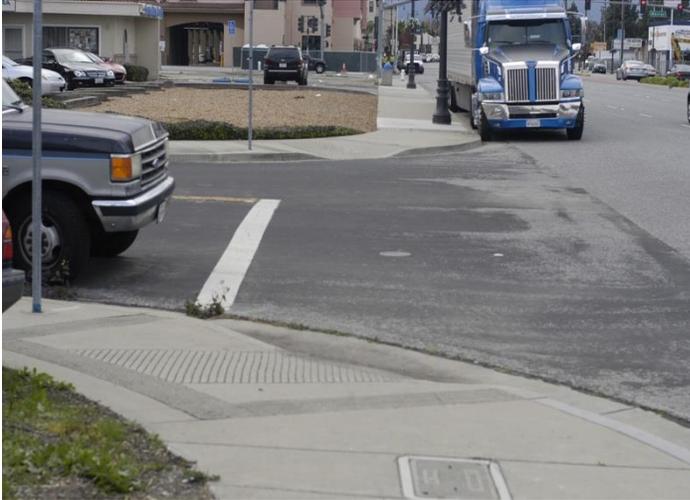
Figure 11: El Camino crosswalk with curb cut but no crosswalk

El Camino also lacked crosswalks for the side street crossings for pedestrians walking along the El Camino corridor (Figure 11). While all of the side street crossings along El Camino Real had curb cuts, the only side street crossings with painted crosswalks were once again for the major side streets of Lafayette, Monroe, Lincoln and Scott. This ends up encouraging people to jaywalk as it is a more much direct alternative to walking up to an extra quarter mile.

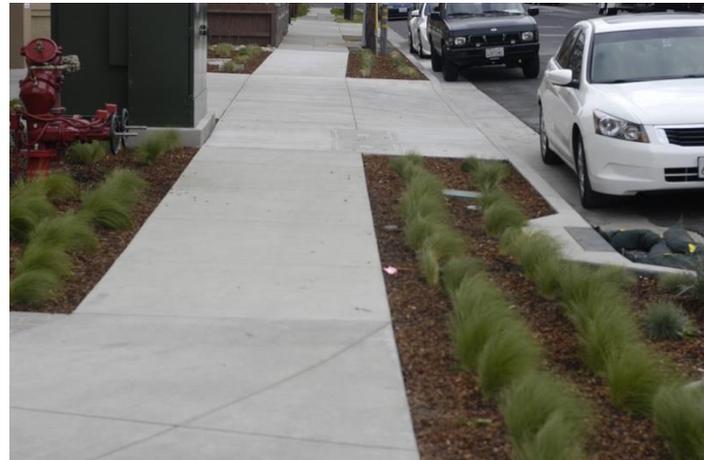
Buffers between pedestrians and traffic were nonexistent along the El Camino itself. Once again, only the side streets studied along the corridor contained any sort of barrier or buffer – usually landscaping (Figure 12) – between pedestrians and the road.

Figure 12: Madison St. with landscaping buffer between road and sidewalk

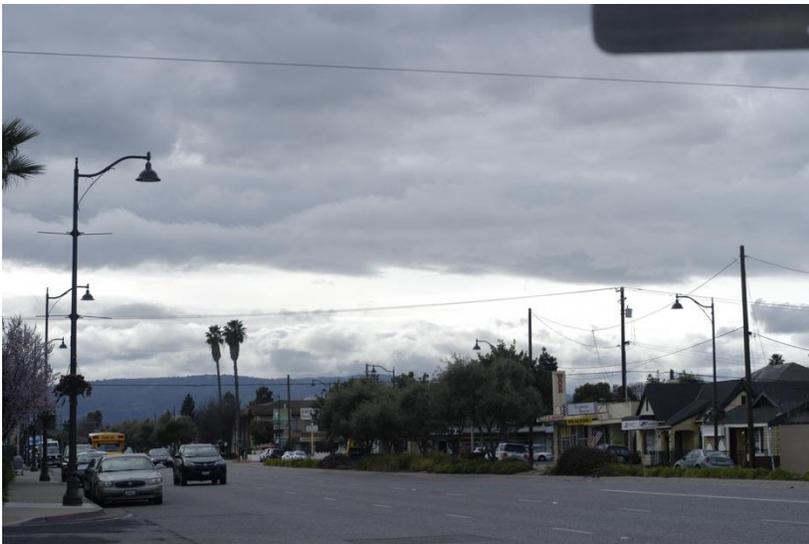
While the entire study area had road-oriented lighting (Figure 13), there was very little pedestrian-scale lighting along the corridor or on the side streets. The only areas observed to have this sort of lighting included blocks 20, 23 and 24. However, this pedestrian lighting was not constant throughout the blocks and was only observed in small sections of the blocks, such as the section of block 22 near the corner of Scott and the El Camino (Figure 14).

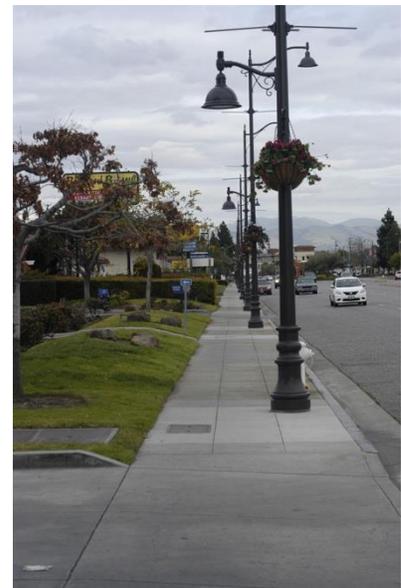
Figure 14: Pedestrian-oriented lighting

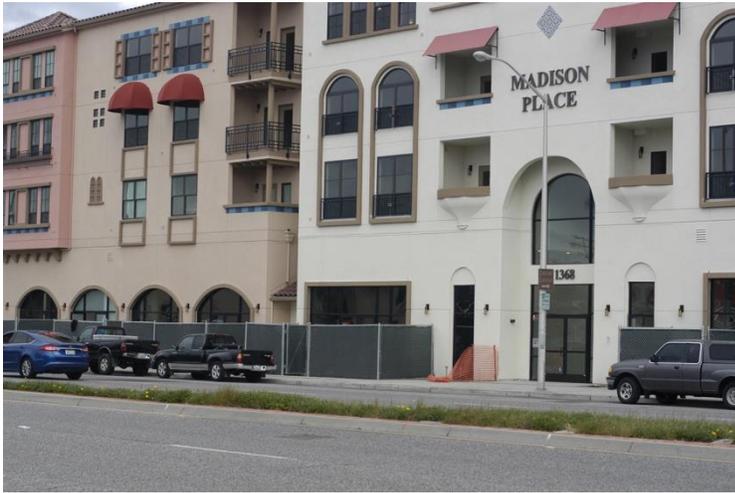
Figure 15: Multi-family housing along El Camino Real

There were two factors we identified for measuring the eyes on street factor along the corridor. The first was the presence of multi-family housing and the second was trafficked businesses (such as restaurants and grocery) open past 5 p.m. Nine of the 24 blocks either contained multiple family housing, or had multiple family housing construction projects in progress (blocks 7 & 22, Figure 4). Ten of the 24 blocks had businesses open late. Together, this resulted in 18 of the blocks having some sort of eyes

on the street surveillance factor (Figure 15). The blocks with the worst eyes on the street level were concentrated on the east side of the corridor, with four of the blocks containing no surveillance located on the east side of Monroe (Figure 15).

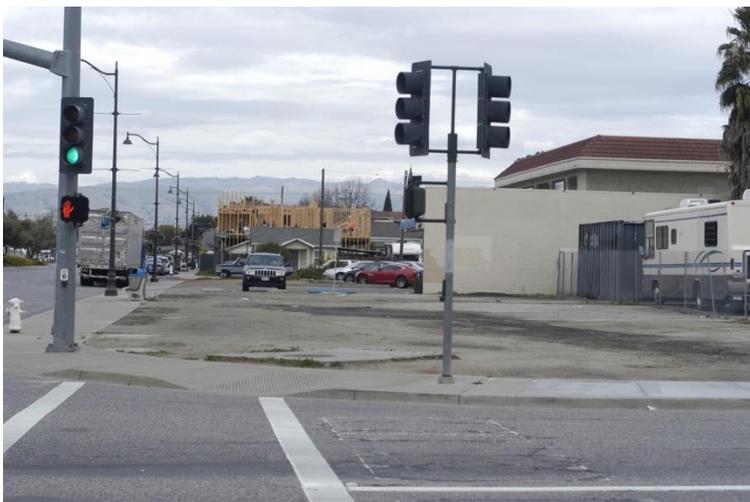
Five blocks along the study corridor contained vacant lots and/or abandoned buildings. They were also concentrated on the east side of the corridor--all but one were located east of Monroe St. One example of a vacant lot identified can be seen on block 10 on the corner of

Figure 16: Vacant lot along El Camino Real

Monroe and El Camino Real on the southeastern corner of the intersection (Figure 16). The front of the lot is completely vacant and the back appears to be a storage facility for RVs, but the space is mainly unused. Block 14 had the highest number of abandoned buildings in our study with three businesses (Civil Auto Pro, Tires Unlimited and M.B. transmissions) that all appear to be abandoned.

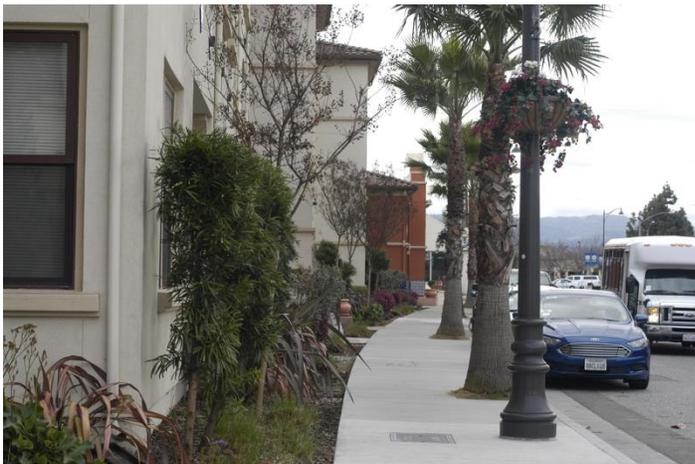
Nine of the 24 blocks had some street trees that provide shading for pedestrians. However, all of these blocks had only minimal street tree coverage, and do not provide adequate shading for pedestrians (Figure 17). Further, 2/3 of these blocks were side streets, despite the fact that side streets only made up 1/3 of the studied blocks. This is most likely to do with the decision of the city to place utilities underneath the sidewalk along the corridor, therefore constricting the placement of trees so that they do not interfere with the placing of the cables.

Figure 17: Street trees along El Camino Real

Only one in six blocks studied contained any sort of street landscaping (Figure 17). All of these blocks were located on side streets, leaving the main corridor with no street landscaping to improve the walking experience.

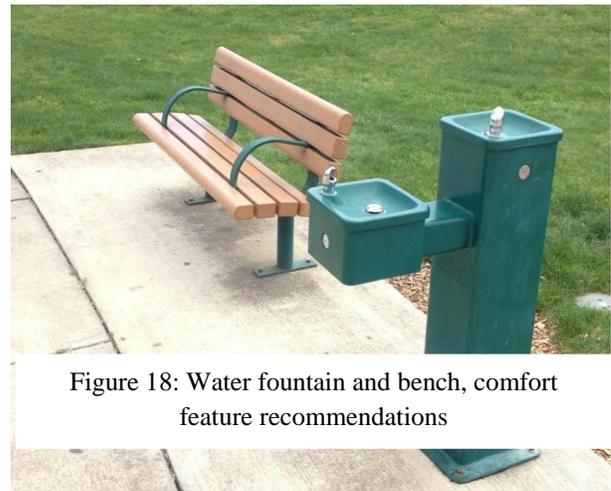
Figure 18: Water fountain and bench, comfort feature recommendations

- Increase the amount of amenities to improve the pedestrian experience through benches, drinking fountains, (Figure 18), and transit shelters.
- Add street trees to shade pedestrians and make for a more comfortable, pleasurable experience. The city s
- Add outdoor dining and gathering areas in addition to the Santa Clara Town Centre.
- Increase architectural articulation, courtyard development, and add public art to make for a more interesting walking experience.

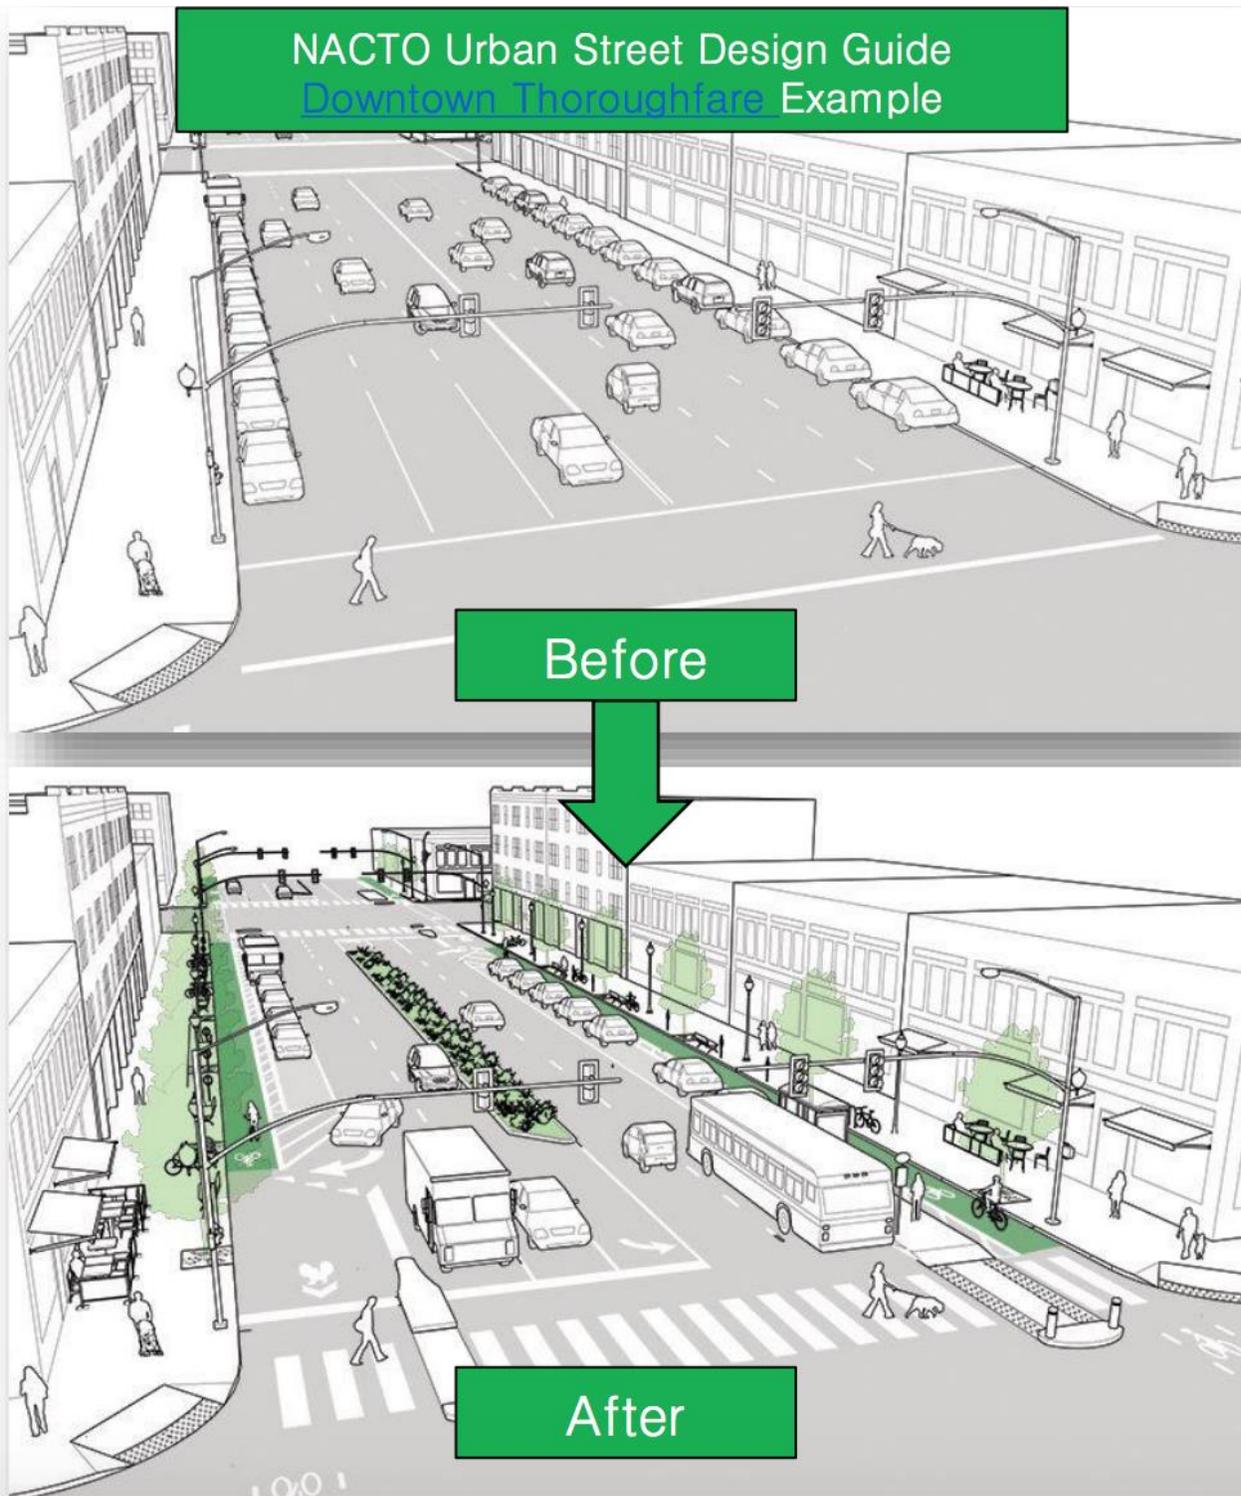
Figure 19: Potential vision for El Camino Real (Guide, 2011).

Our recommendations are inspired by the complete streets design concept by the California Department of Transportation illustrating how a six-lane corridor, similar to the El

Camino, can be converted into a tree-lined, well-lit, mixed-use, pedestrian, bike, car and transit-oriented space for all. This example gets at most aspects of the walkability hierarchy that we have mentioned. Safety is better met through improved crosswalks, better lighting, buffers between the road and pedestrians, and mixed-use housing that provides multiple family housing and businesses to help increase the “eyes on the street.” Comfort and pleasurability are also met through street trees and landscaping that provide shade and an interesting streetscape to travel through, and increased amenities such as benches, bike racks, and outdoor seating improve the pedestrian experience.
